# Manhole Inspection Summary

Manhole # S17KK\_009MH

Insp Date: **3/3/09 12:45 PM**

**Location** Address: **2228 HERBERT ST**

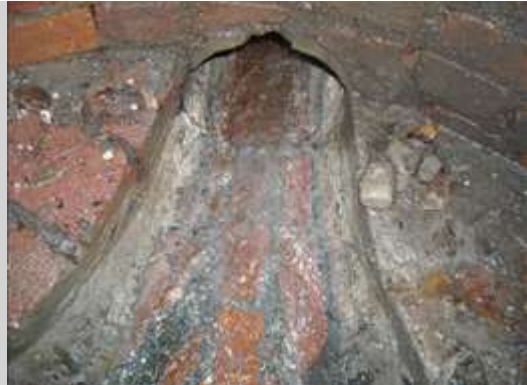
12 O'Clock Outflow

8 in. Circular Gravity Sewer  
Pipe Out @ 12 O'Clock

Pipe Height: **8.4** (in.) Rod and Bar (Angled)  
Pipe Material: **Clay** ☐ Pipe Lined  
Invert Depth: **7.92** (ft.) Flow Characteristics: **Slow**  
Deposits: ☒ None ☐ Mud ☐ Sludge ☐ Debris ☐ Grease  
Silt Depth: (in.) Deposits Extent:  
Infiltration: **None** Pipe Seal Cond: **Sound**

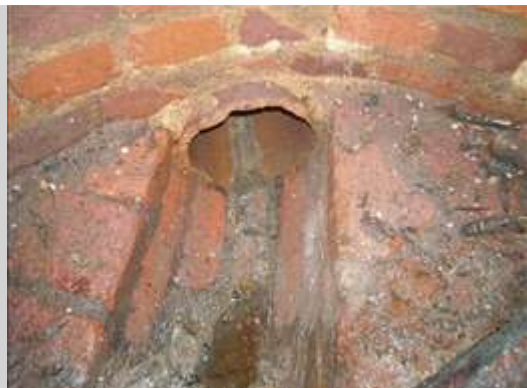
4 O'Clock Inflow

6 in. Circular Gravity Sewer  
Pipe In @ 4 O'Clock

Pipe Height: **6** (in.) Rod and Bar (Angled)  
Pipe Material: **Clay** ☐ Pipe Lined  
Invert Depth: **7.79** (ft.) Flow Characteristics: **Slow**  
Deposits: ☒ None ☐ Mud ☐ Sludge ☐ Debris ☐ Grease  
Silt Depth: (in.) Deposits Extent:  
Infiltration: **None** Pipe Seal Cond: **Sound**

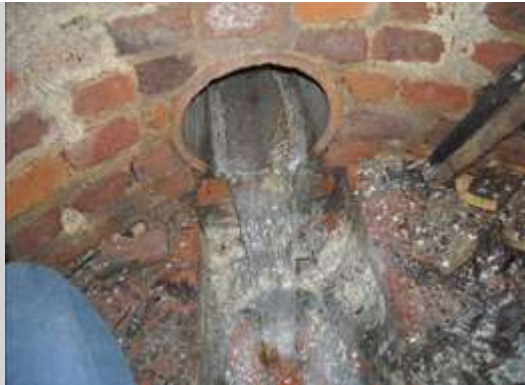
6 O'Clock Inflow

10 in. Circular Gravity Sewer

Pipe In @ 6 O'Clock

Pipe Height: **9.6** (in.) Rod and Bar (Angled)

Infiltration: **None**

Pipe Seal Cond: **Sound**

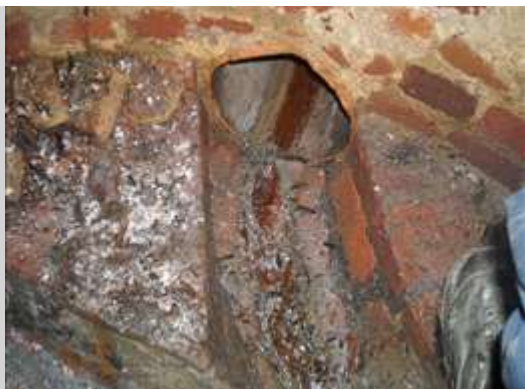
8 O'Clock Inflow

10 in. Circular Gravity Sewer

Pipe In @ 8 O'Clock

Pipe Height: **9.6** (in.) Rod and Bar (Angled)

Infiltration: **None**
